Aviation Maintenance Alerts

AC No. 43-16A

**ALERT NO. 252
JULY 1999**

**Improve Reliability-
Interchange Service
Experience**

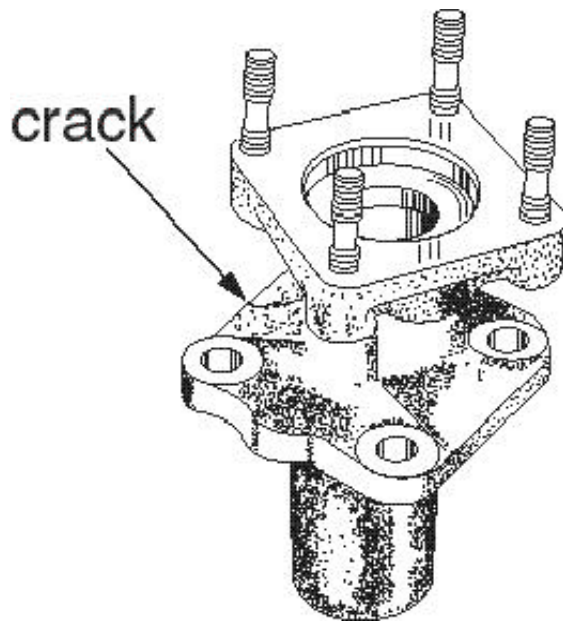
During an engine operational check, the technician found an oil leak at the rear of the engine and a crack in the hydraulic pump adapter flange (P/N LW-12540). (Refer to the following illustration.)

The submitter did not offer a cause for this defect; however, he recommended that the manufacturer redesign the adapter flange to provide a more substantial structure. The submitter stated he has experienced several other similar failures.

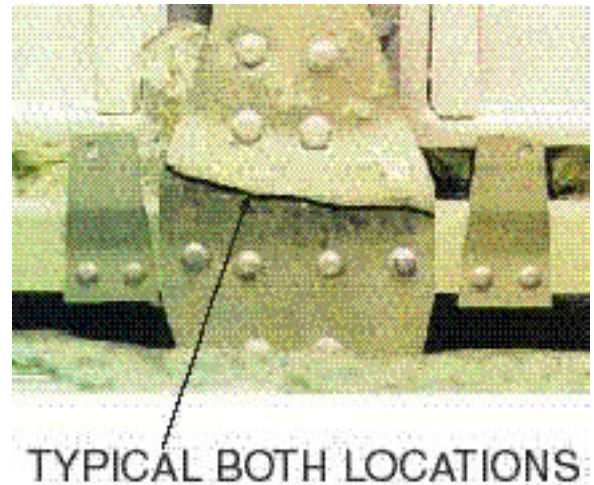
During a scheduled inspection, the technician found two fuselage frame doublers broken at fuselage stations (FS) 226 and 246 at water line (WL) 117. (Refer to the following illustration.)

The broken doublers were "puckered" parallel to the break. These doublers are an integral part of the aircraft pressure vessel and deserve one's full attention during inspections and maintenance.

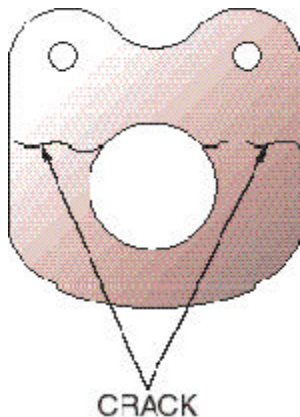
An investigation revealed the right brake caliper (Cleveland P/N C163030-011) was cracked in two places. (Refer to the following illustration.)

The submitter speculated faulty material, improper heat treatment, excessive brake heating, and/or the effects of side loads imposed on the landing gear may have caused the defect.

It would be prudent to inspect the brake calipers closely at every opportunity.

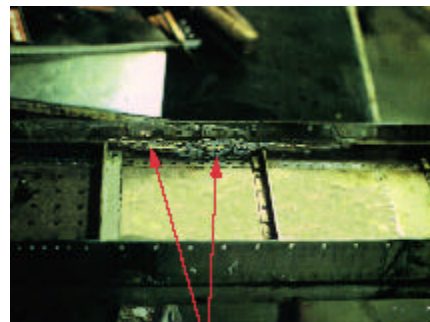
CORROSION AREA

During an annual inspection, the technician removed the right wing and discovered severe corrosion on the center section beam assembly (P/N 415-13102) and the lower wing spar cap. Intergranular corrosion consumed approximately 5 inches of the spar cap. (Refer to the following illustration.)

This area is not accessible for inspection without removing the wing. The submitter recommends that the manufacturer design an inspection panel located on the bottom skin to allow periodic inspection of this area.

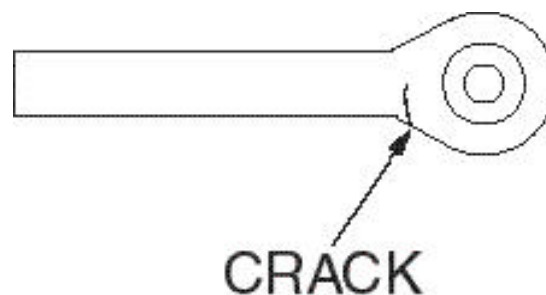
The technician discovered the rod-end bearing (P/N 452-729) installed on the nose gear actuator cylinder (P/N 35797-02) broke and allowed the nose gear to free fall to the "down-and-locked" position. The broken rod-end displayed evidence of a pre-existing crack. (Refer to the following illustration.)

To detect a crack at this location, disassemble the rod-end from the nose gear downlock mechanism. The submitter speculated metal fatigue caused this defect, and recommends inspecting the rod-end bearing frequently.

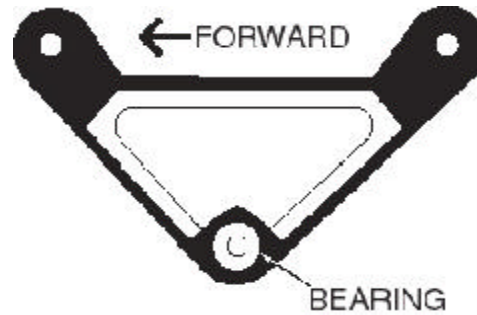
Further inspection disclosed that a loose bearing at the lower pivot point caused the free play in the bellcrank assembly (P/N 600N7605-1). The submitter stated the bearing nearly fell out of the bellcrank. (Refer to the following illustration.) The submitter stated this is the third occurrence he has experienced with a loose bellcrank bearing. All three of the occurrences occurred on very low time helicopters.

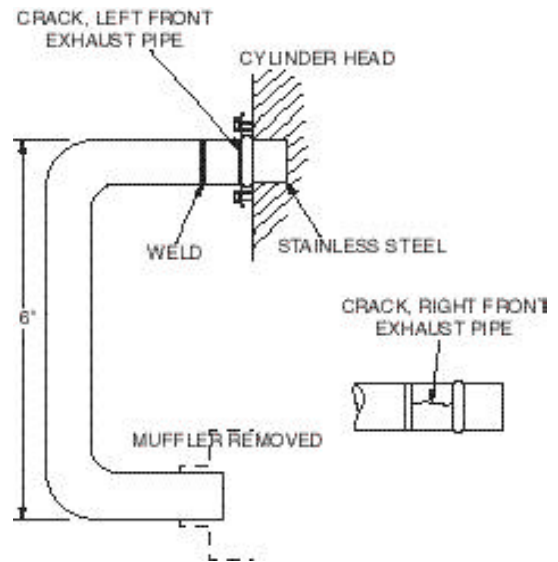
An examination of the wreckage revealed that two of the three propeller blades broke approximately 10 inches from the center of the hub. Further inspection disclosed a broken front left engine exhaust pipe. The technician presumed the exhaust pipe damaged the propeller blades when it exited the aircraft. The available evidence indicated a crack developed around the circumference of the pipe at the point where it entered the engine cylinder head. Another crack was found on the right front exhaust pipe. (Refer to the following illustration.)

The submitter stated the remaining section of the exhaust pipe showed evidence of “fatigue cracking.” The builder modified the exhaust system and flew the aircraft without the

mufflers. The process of welding stainless steel to mild steel raises serious questions concerning structural integrity. Welding stainless steel to mild steel requires proper adherence to a strict technical process.
